TECHNICAL REPORT S-77-1

INVESTIGATION OF CONSTRUCTION TECHNIQUES FOR TACTICAL BRIDGE APPROACH ROADS ACROSS SOFT GROUND

February 1977

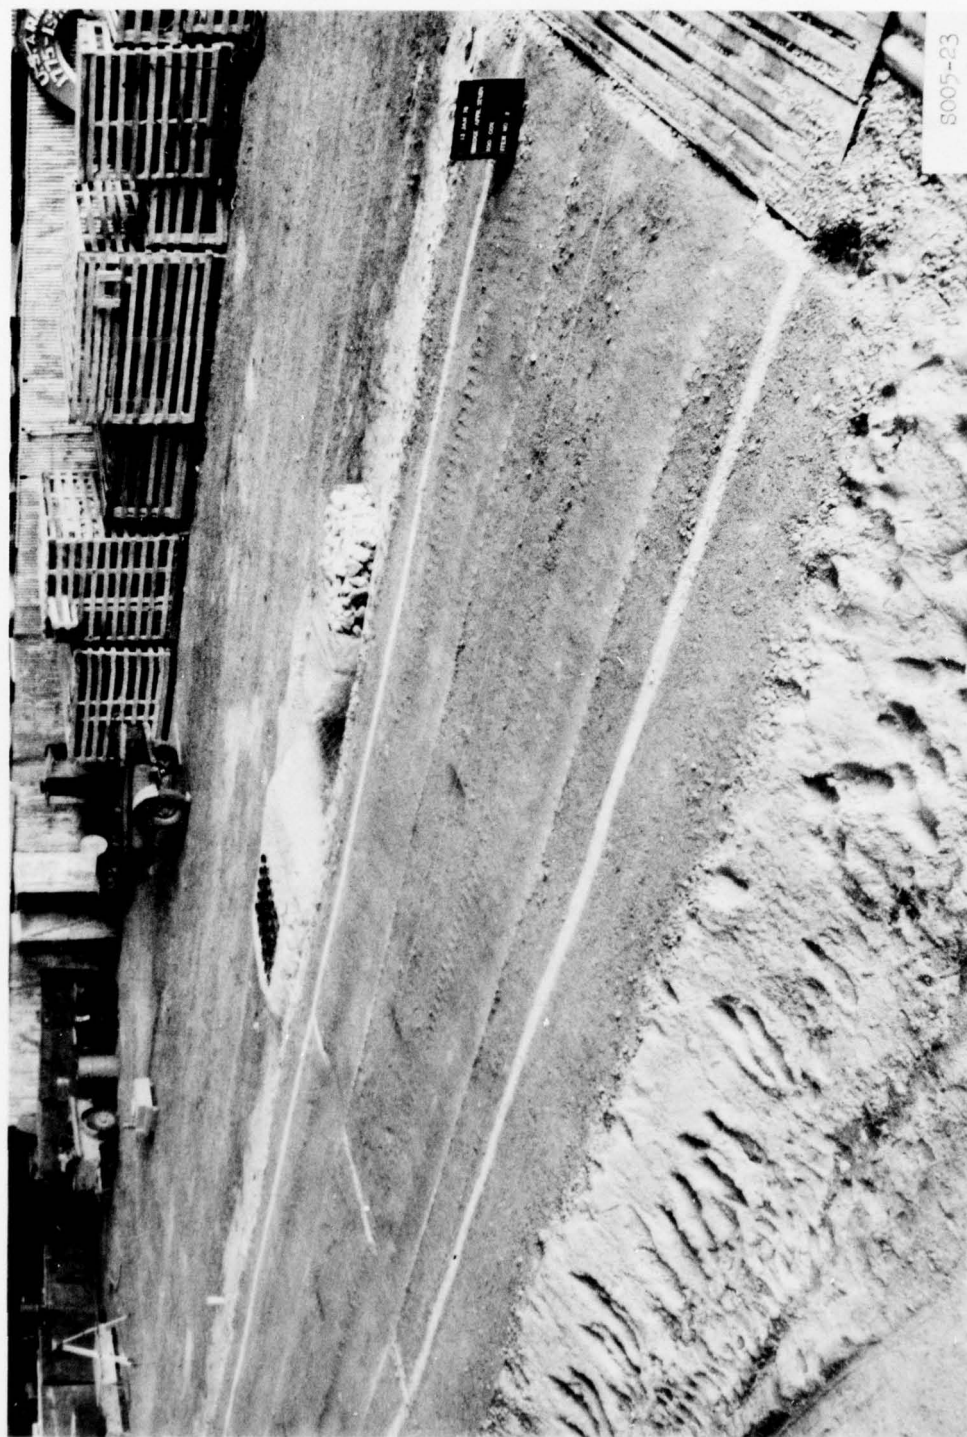
Photo 18. Item 2 after 100 coverages

35. This item performed quite well throughout the 54,000 coverages. Photos 18, 19, and 20 show this item after 100, 5500, and 54,000 coverages, respectively. Plate 4 shows typical cross-section data of the surface of the item at various coverage levels and also the contour of the bottoms of the gabions after 54,000 coverages. Slight upheaval of the gabions did occur at both edges of the item and also at the center line between the wheel paths.

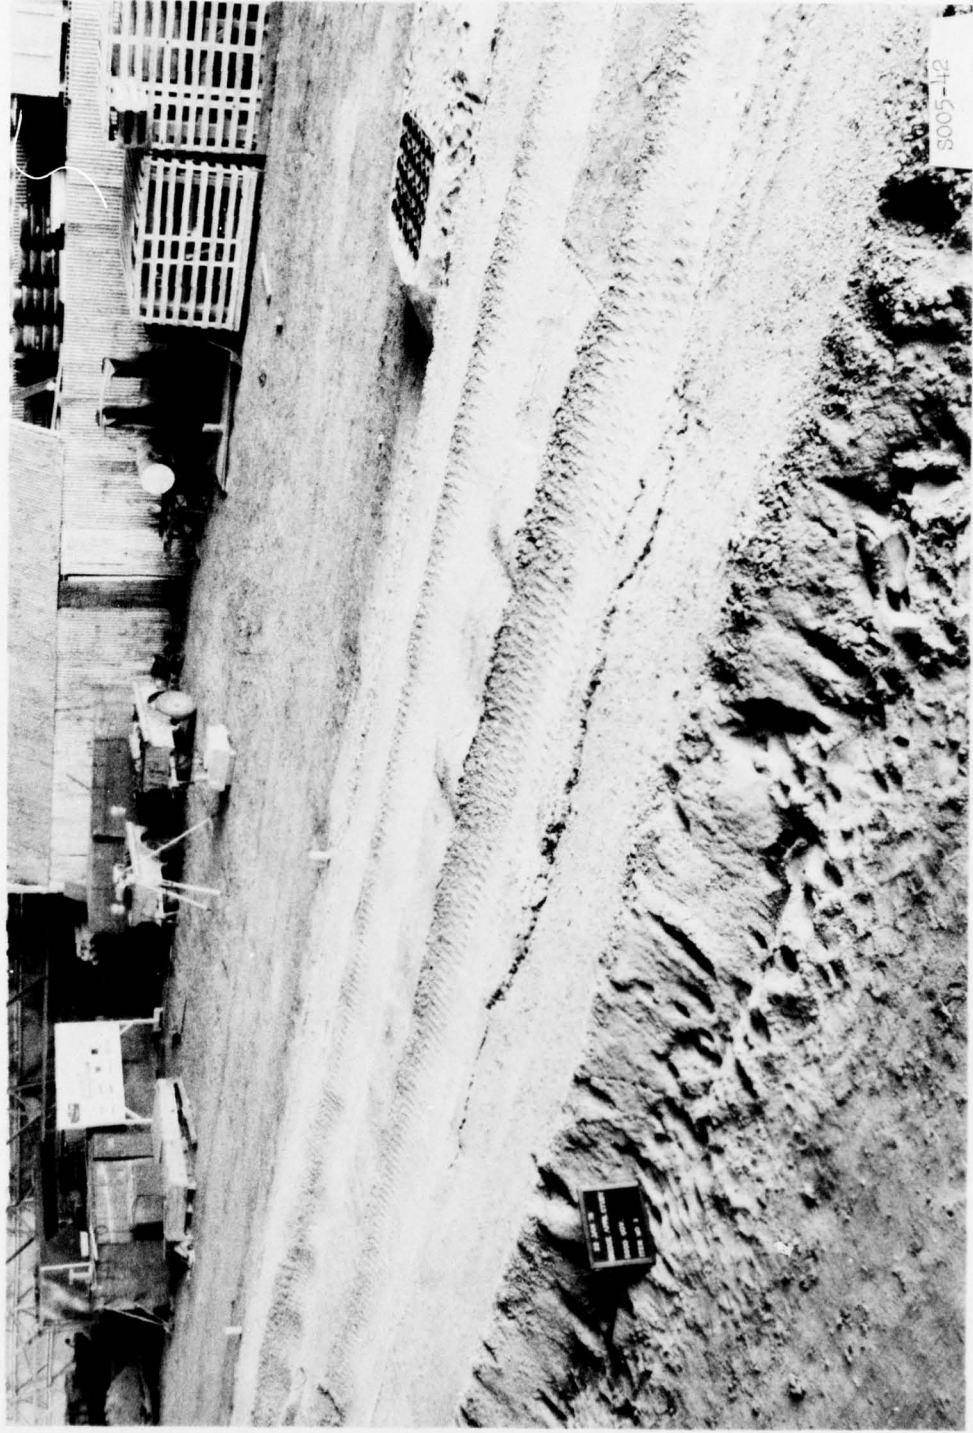
Photo 22. Item 3 after 5500 coverages

37. Performance of this large-compartment sand-confinement item was surprisingly good. A total of 11,500 coverages were applied before an 11-in. rut developed in the west wheel path. At 100 coverages (Photo 21) the item was in excellent condition and had an average rut of 2.2 in. At 5500 coverages (Photo 22), the average rut was 7.3 in. and signs of upheaval and shifting of sand within the compartments could be seen. Photo 23 shows the item after 11,500 coverages when 11 in. of rutting had finally developed in the west (foreground) wheel path. Typical cross-section data for this item are shown in Plate 5. The gabion wire and the polyester fabric were still in excellent condition at the conclusion of traffic.

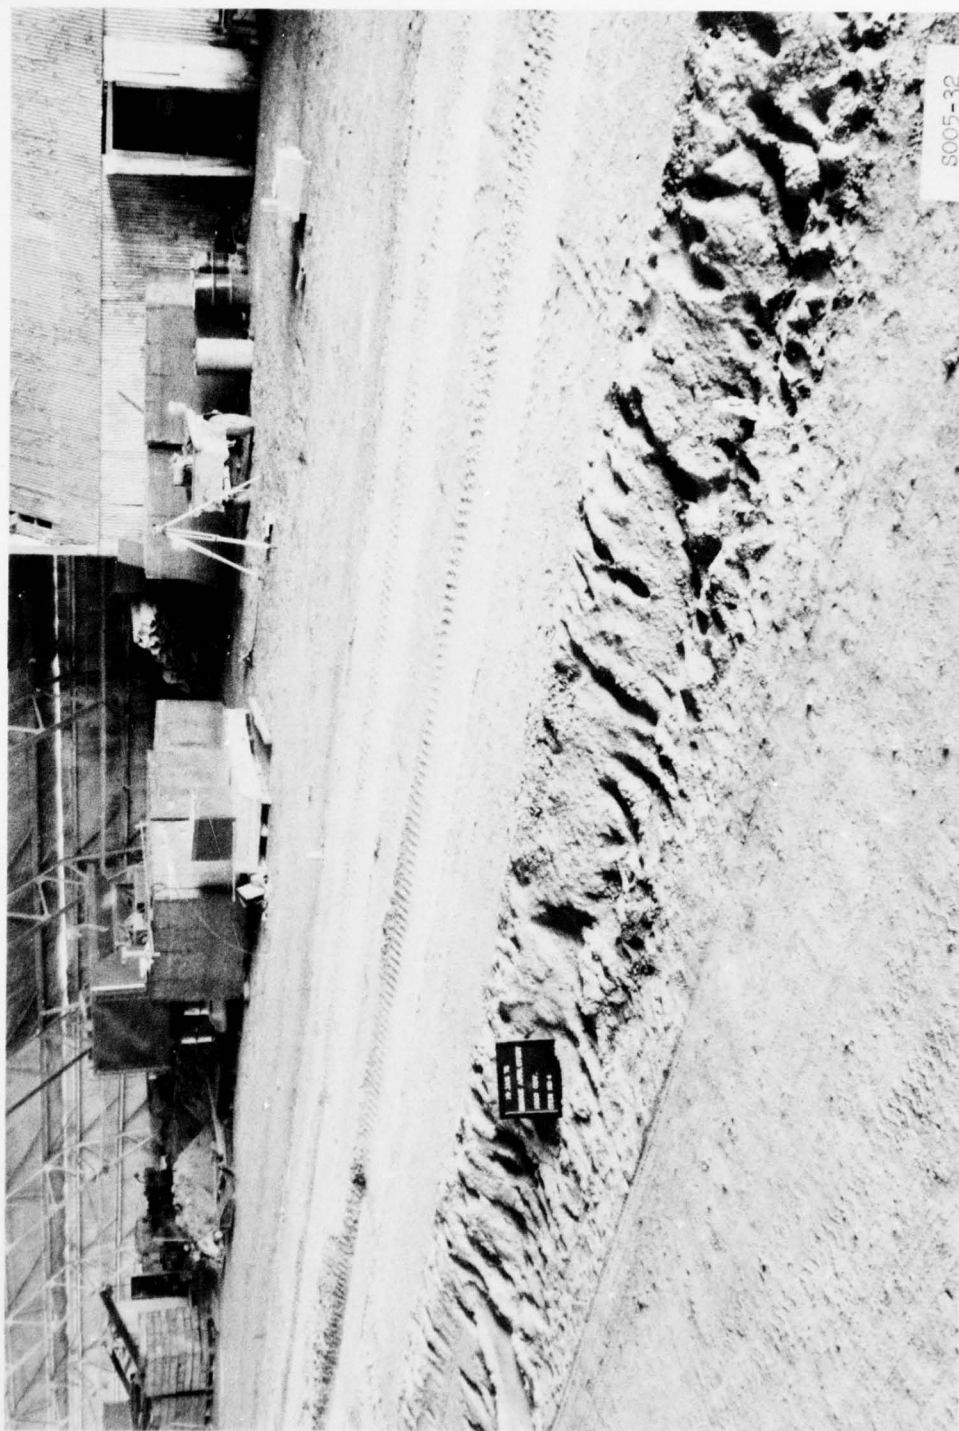
Photo 25. Item 4 after 1000 coverages

38. This small-compartment sand-confinement item performed extremely well during the first 500 coverages. After 100 coverages (Photo 24), the average rut depth was 1.5 in. Visual observation showed this item to be very stable during the first 500 coverages. However, after 500 coverages, the tandem-axle load was increased from 25,000 to 35,000 lb, and the item performed significantly different with the new traffic load. Additional traffic caused a spot type failure to start to develop in the west wheel path. Photo 25 shows the item after 1000 coverages when the potential failure was noticed. Photo 26 shows the item after 2500 coverages when the average rut depth was slightly over 6 in. At this coverage level, the plastic tubing became visible as the spot failure continued to develop. After 5500 coverages (Photo 27), an 11-in. rut had developed at one spot, and the differential of the truck began to lift the plastic tubes from the item. It should be noted in Photo 27 that although half the item had developed an 11-in. rut, the remaining portion had an average rut of

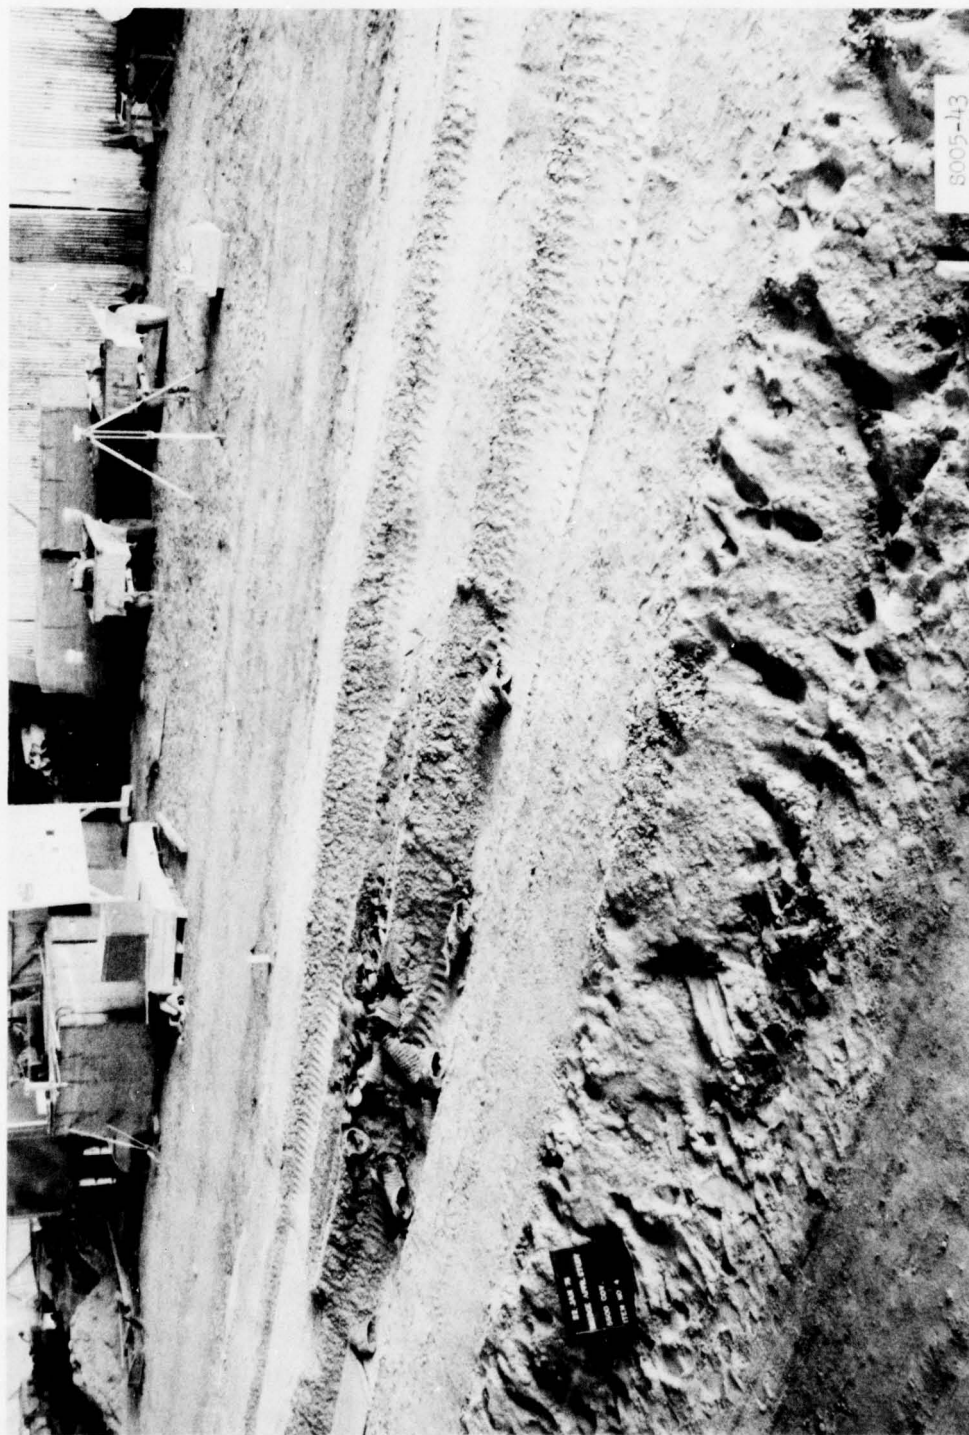
Photo 27. Item 4 after 5500 coverages

only approximately 6 in. Typical cross-section data are shown in Plate 6. Photo 28 shows a typical cross-section view after the wearing surface was removed after 5500 coverages. The individual sand-filled plastic tubes along each wheel path had been pushed into the subgrade. This caused the subgrade to upheave between the wheel paths and along the outer edge of each wheel path.

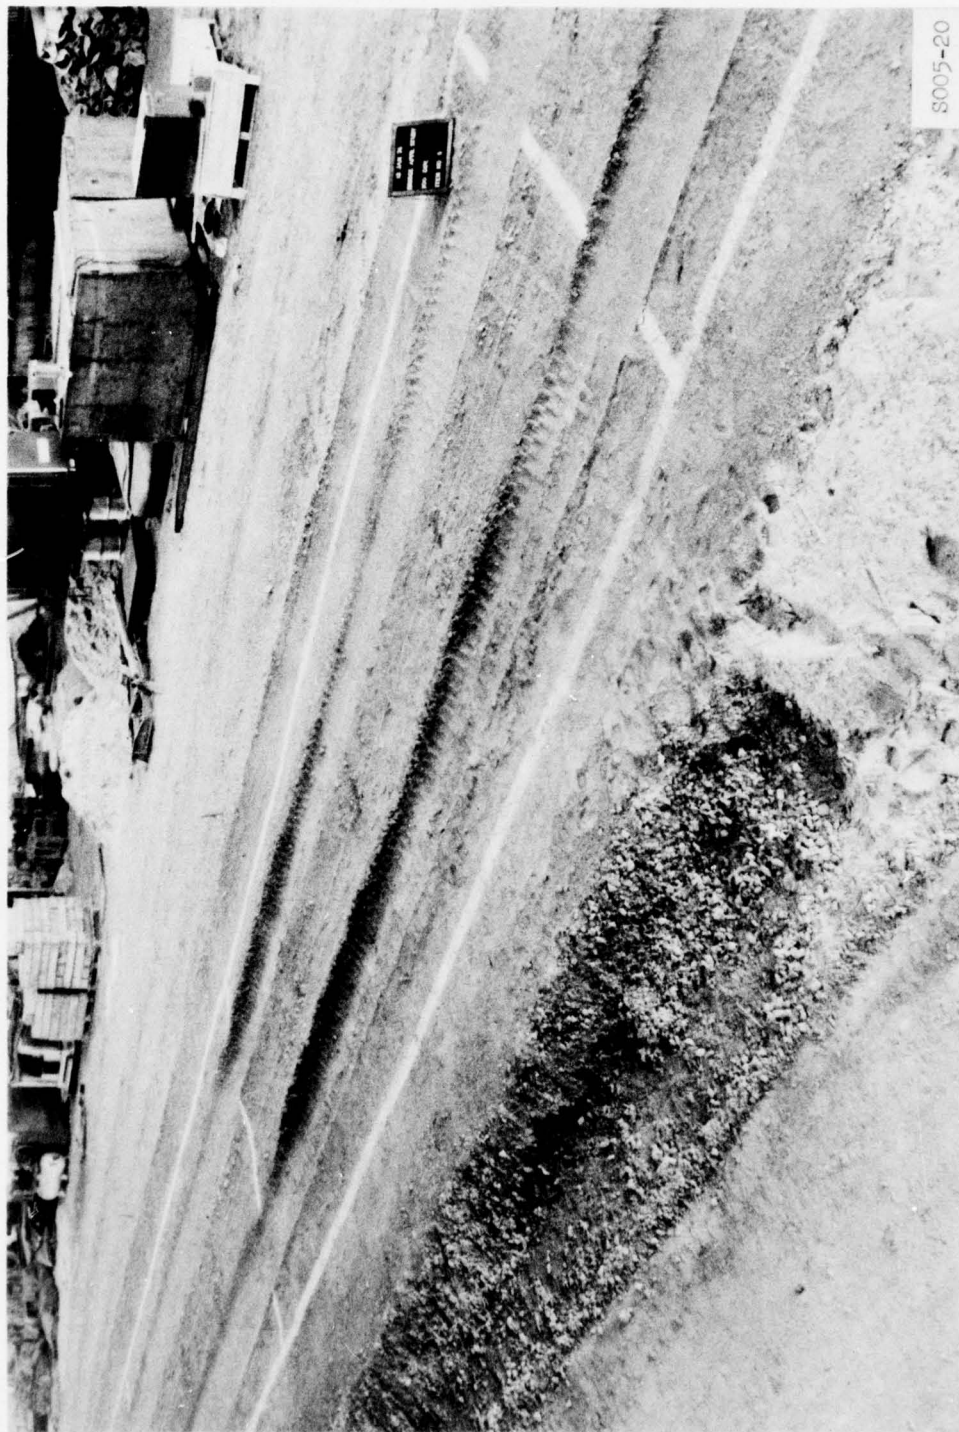
Photo 29. Item 5 after 100 coverages

40. Performance of the control item was slightly better than predicted. After 100 coverages (Photo 29), the average rut depth was 4.5 in. By 200 coverages (Photo 30) an 11-in. rut had developed. Plate 7 shows typical cross-section data for this item during traffic. A trench excavated across the item showed that the crushed-stone base had penetrated approximately 3 in. into the subgrade. The trench also showed that the subgrade material had migrated 10 in. upward into the base near the center line between the wheel paths. This subgrade material had migrated from the west wheel path, indicating that the subgrade was slightly weaker on this side.

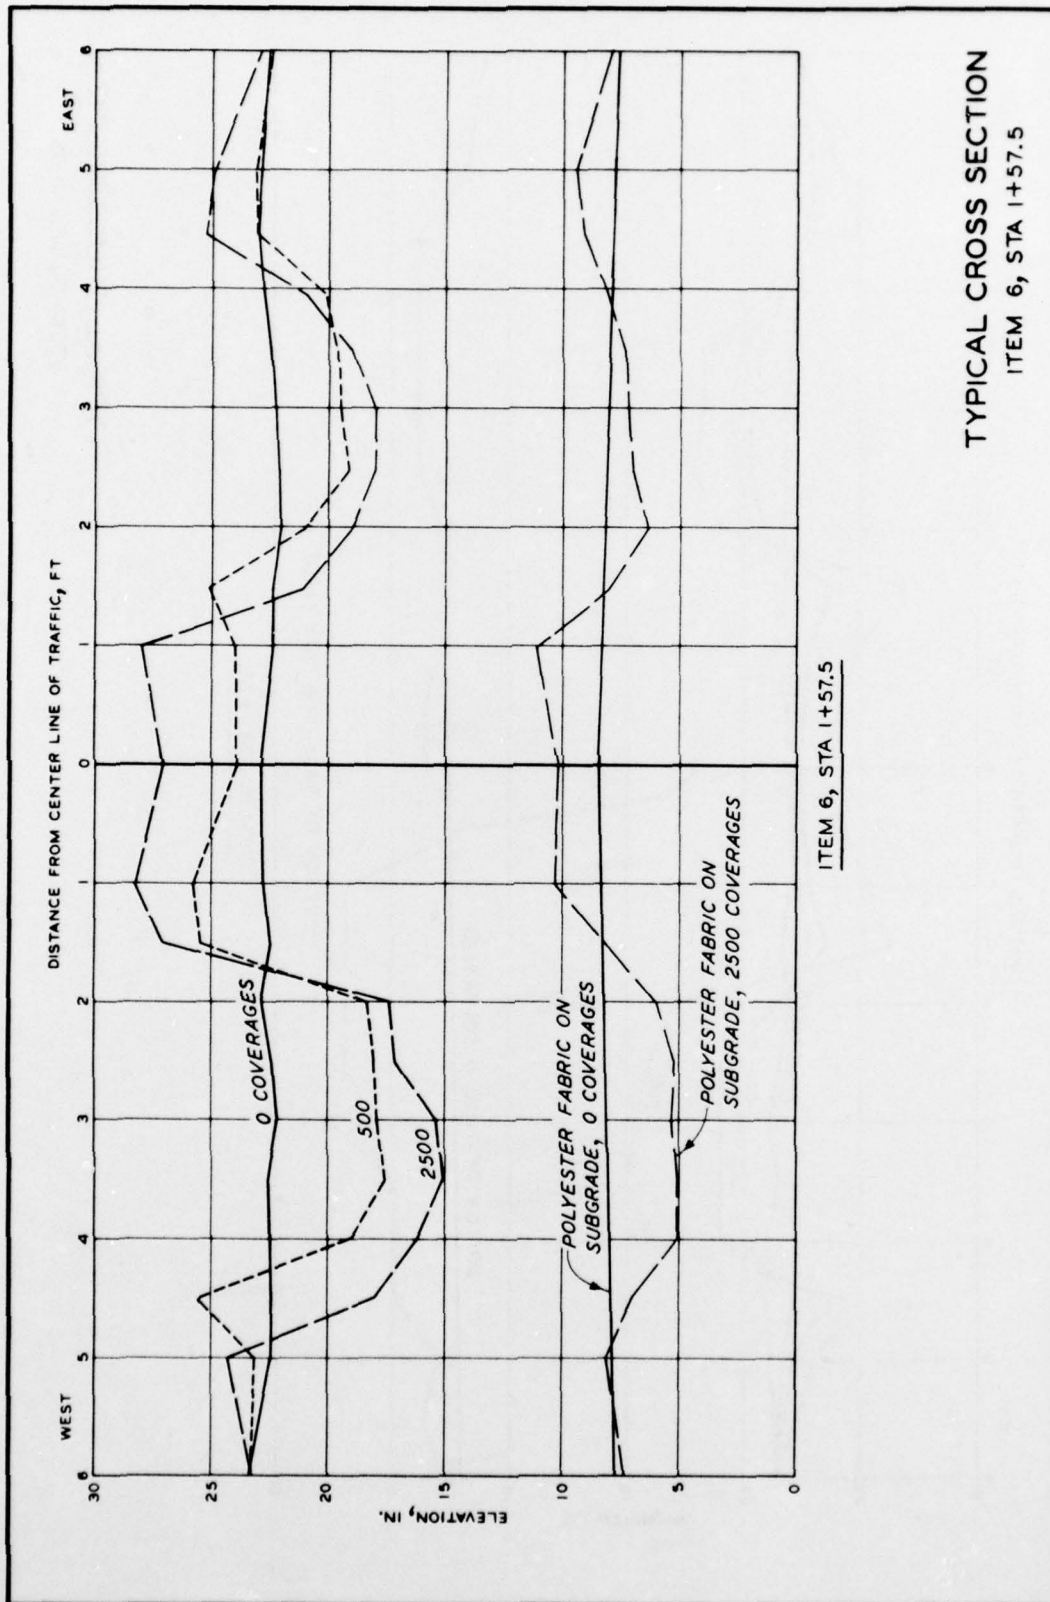
PLATE 8

43. After 2500 coverages (Photo 33), an 11-in. rut had developed in the west wheel path. The rutting was less in the east wheel path. Plate 8 shows cross-section data where the test trench was excavated in this item. The polyester fabric had absorbed a lot of clay particles and had stretched to the configuration shown in Plate 8. The fabric did not tear and was successful in separating the base and subgrade during traffic.

44. Failure of this item was caused by rutting and upheaval of the subgrade. This caused the base to shear and move outward and up.

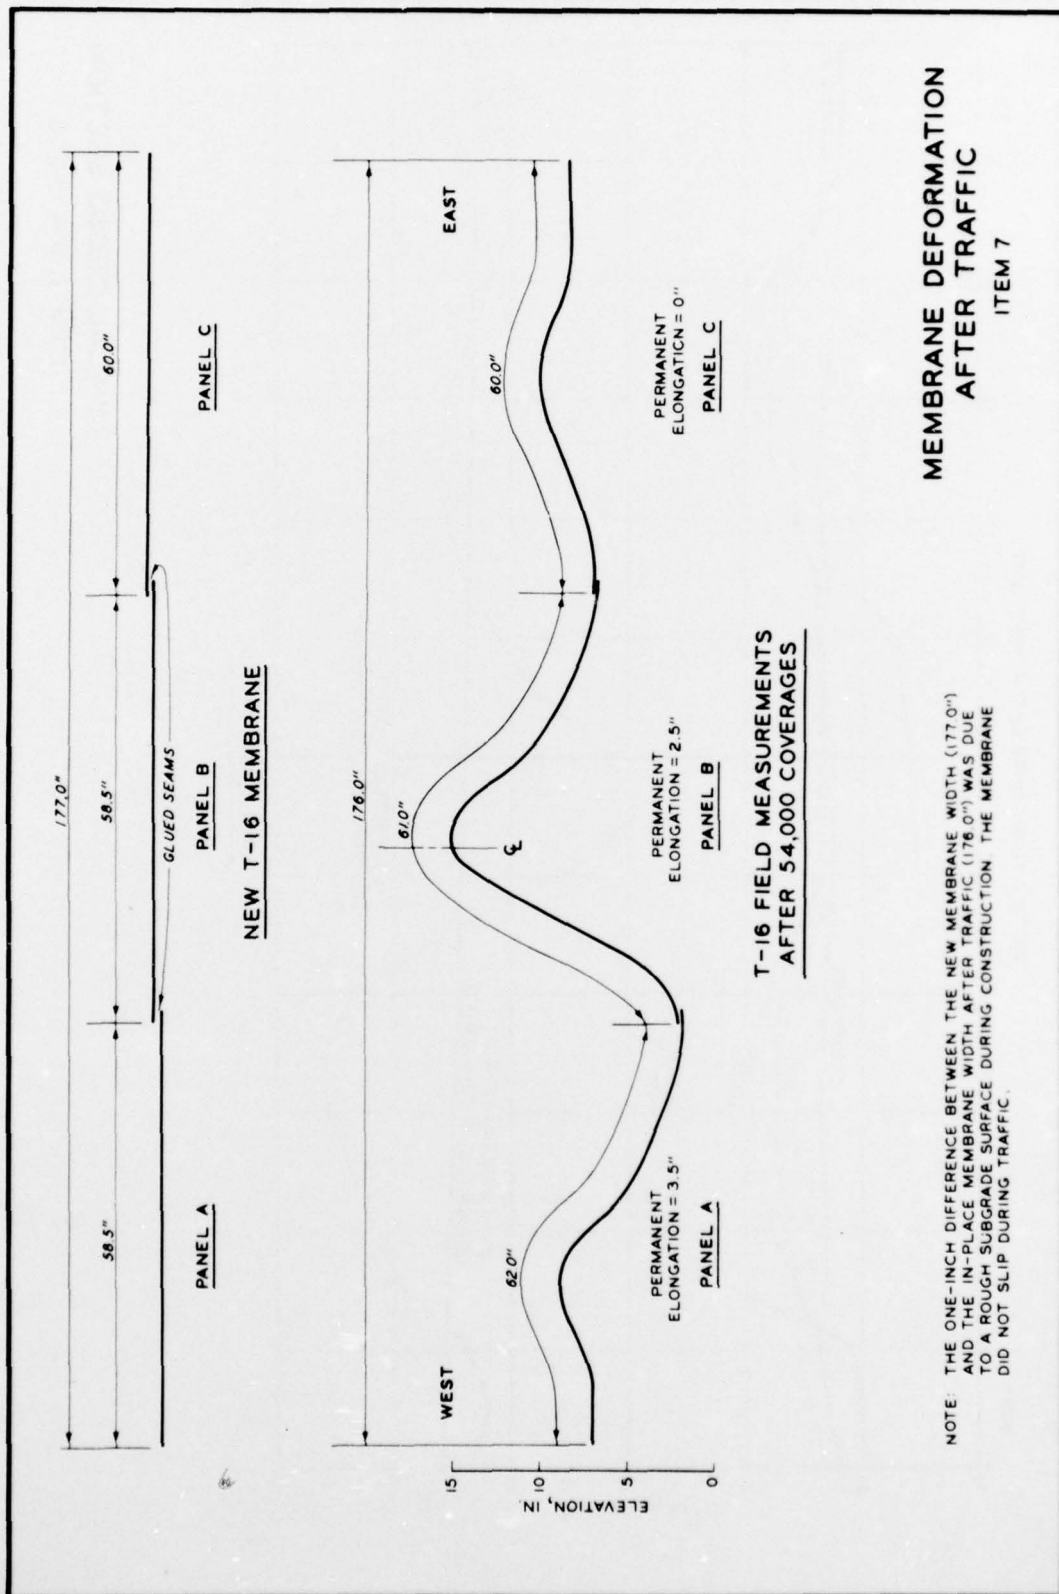
PLATE 10

46. The base remained 14 in. thick except where it was stretched to conform with the subgrade or where it was disturbed by the differential on the truck. Plate 10 shows how the membrane was deformed during traffic.
